## PROBLEM: FILM SNAPPING WHEN WRAPPING

### Description:

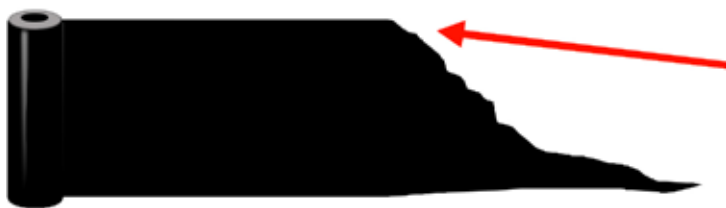
#### Edge Break

This shape indicates break started at the top edge of the film.

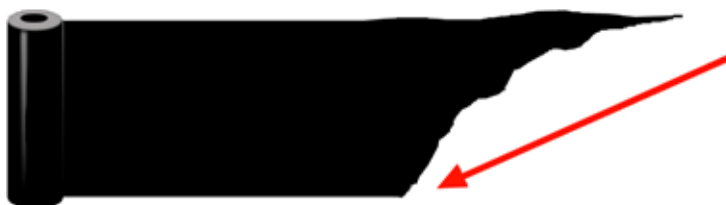
#### Edge Break

This shape indicates break started at the bottom edge of the film.

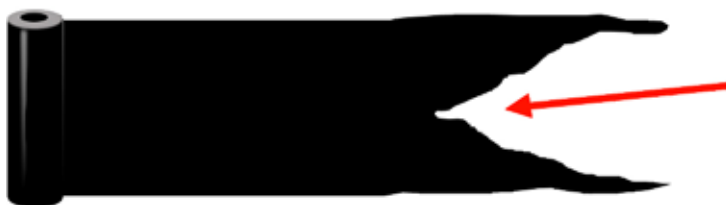
#### Centre Break

This shape indicates break started at the centre of the film.

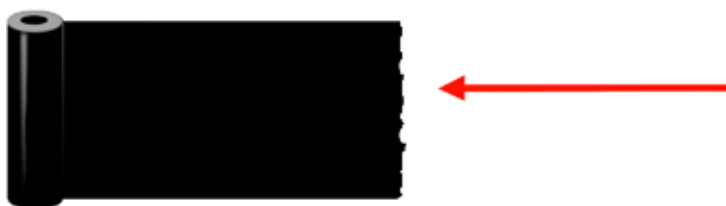
#### Tension Break

This shape indicates break caused by over-tension to roll

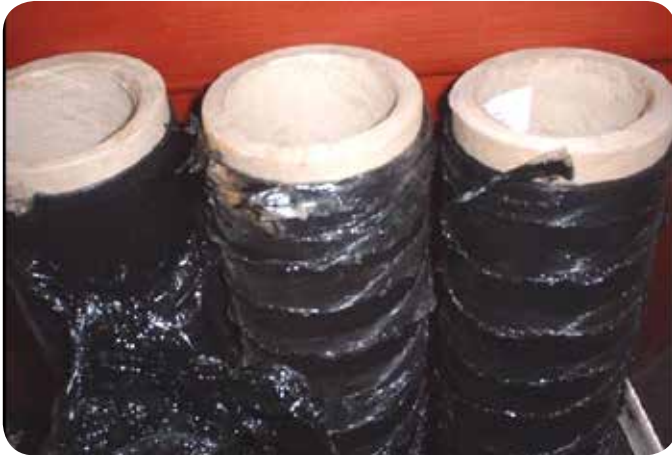
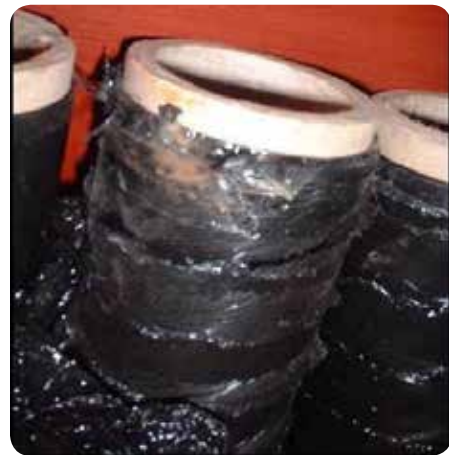
### Roll damage

If the film has a long tail on one edge and short on the other – the break started on the short edge side of the film. This damage usually ends up with a 'spiral' tear of the film, leaving a spiral of film on the roll. By carefully un-winding the spiral tail on the roll, it is easy to see which edge the break started.

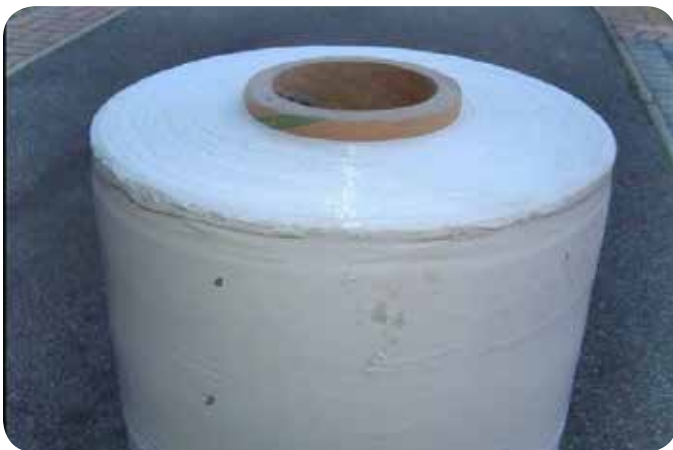
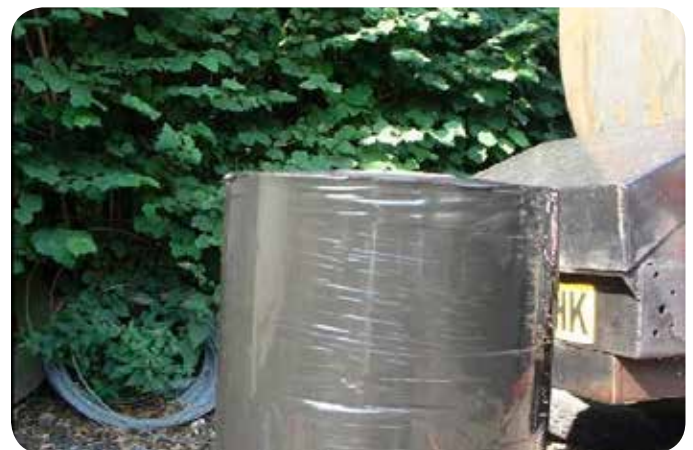
### Damaged rolls

Slightly scuffed or damaged film rolls cause most Edge Breaks. Un-packing and loading of the film roll are the main reasons that such damage can occur, and great care must be taken not to scuff or mark the roll edges. Sometimes a break can occur if the film has simply been flattened on the edge of the roll.

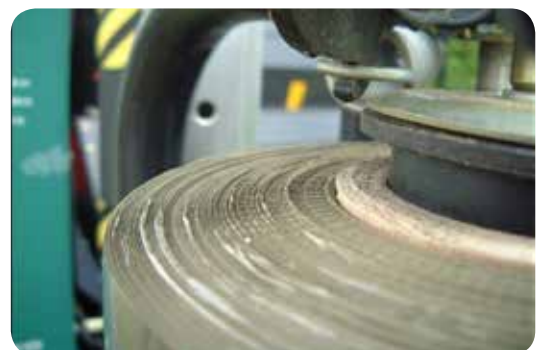
### Film Winding

If the film has not been wound evenly onto the core, it is possible that some film layers will have over-lapped others, trapping them when the film is un-wound and causing the film to break.

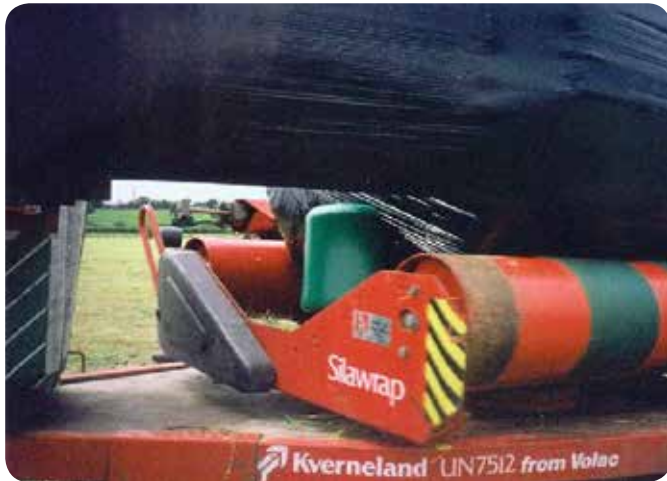
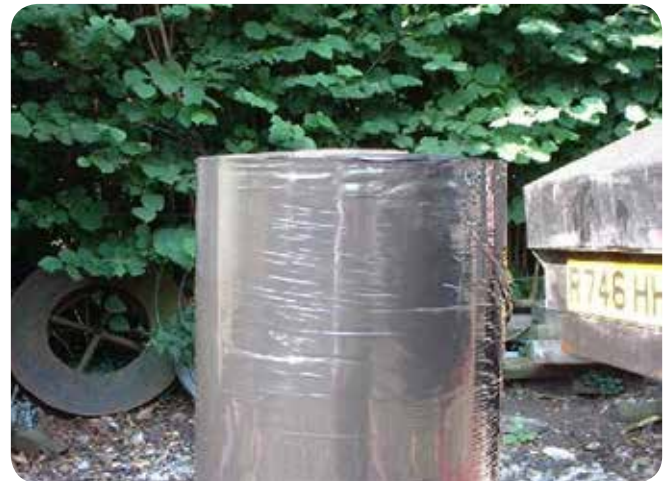
### Film Roll Alignment

If the film is not correctly aligned to the bale, the turntable below can easily damage it. This can happen if the roll location is not central to the bale, but also if the film is not centred on the core, meaning that the height the film is touching the bale may be wrong. Check carefully that the film roll has the core protruding evenly at both ends.

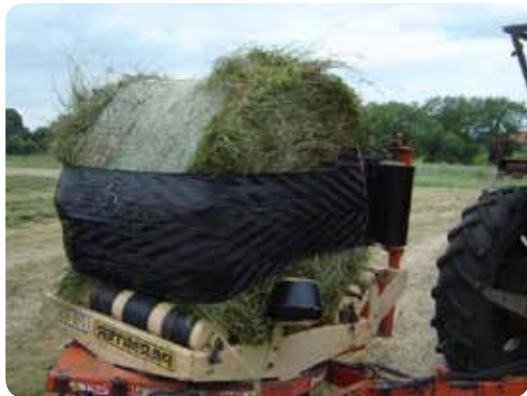
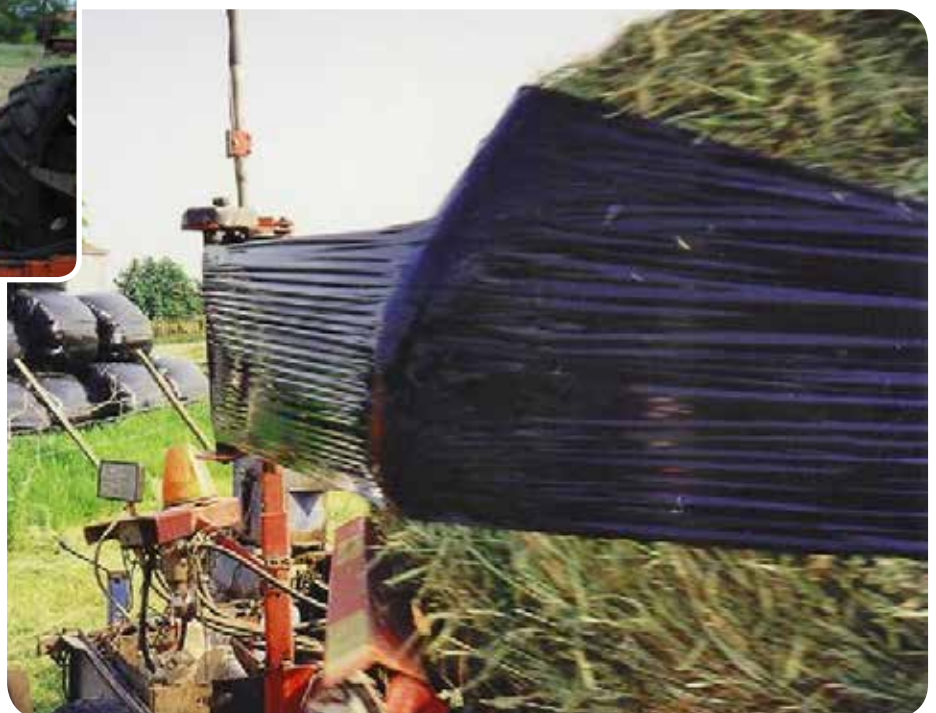
### Bale Shape

Badly shaped bales, or bales with poor netwrap coverage, can leave exposed 'shoulders' which can easily cause damage to the film when being applied to the bale. This problem is worse when wrapping crops with a higher Dry-Matter (DM) content, such as haylage.

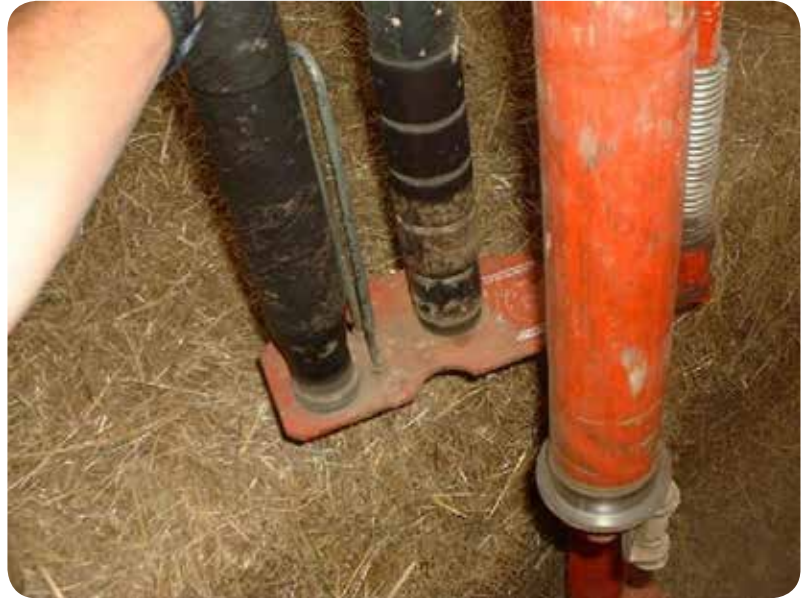
### Dirty PSU rollers

If the PSU rollers on the wrapper are dirty or sticky, dirt and crop debris can easily become stuck to the rollers, causing damage to the film as it passes over them. It is not necessary for the film to have been punctured to cause it to break, often the smallest piece of dirt or debris can create a weakness in the film as it is being stretched that will cause it to fail.

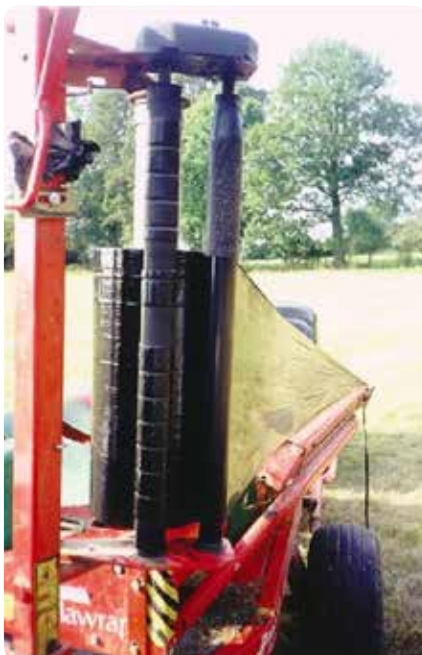
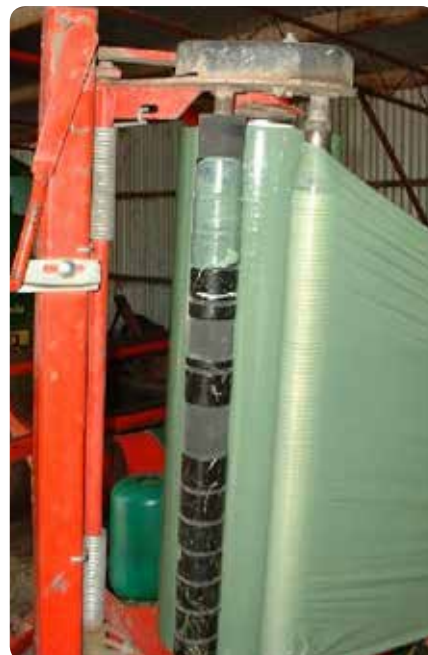
### Dirty PSU rollers

If the PSU rollers are sticky with film tack residue, the film will begin to stick to the rollers instead of stretching over them and going to the bale. Apart from the fact that this will cause the film to over-stretch, causing excessive neck-down, the film can stick fast to the roller which can tear holes in the film causing it to break.

To over-come this, PSU rollers should be cleaned regularly, by rubbing vigorously with a cloth soaked in a solvent based cleaner. If the PSU has rubber coated rollers, it may be necessary to clean the surface then rub down with a hard wire brush, to create grip on the rollers.

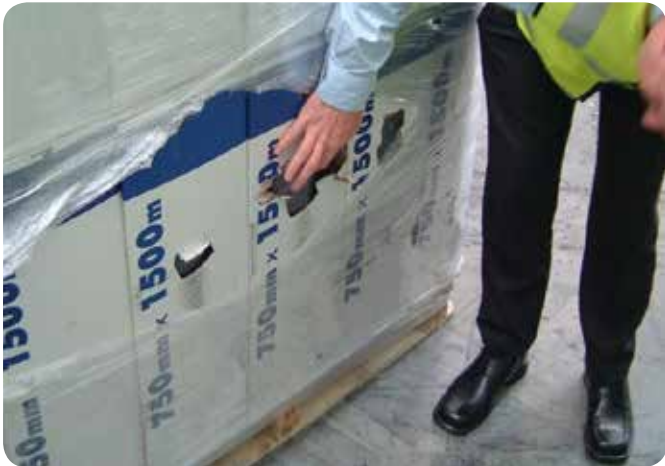
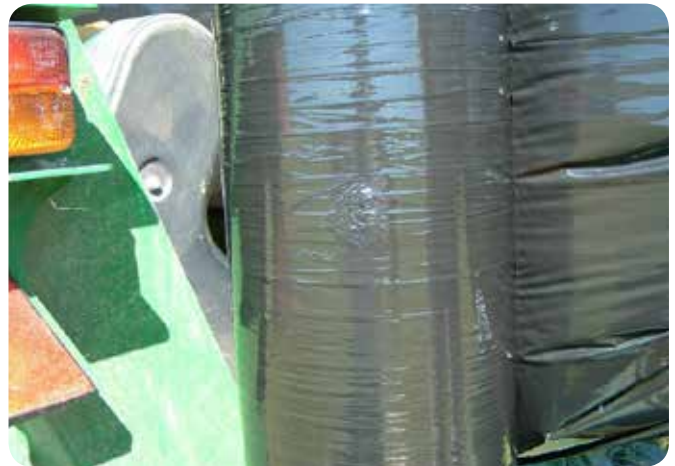
## Damaged Film Roll

If the film roll has been scuffed, either during loading or before being un-packed, surface damage to the roll may result in a break when being stretched through the PSU rollers. It is not necessary for the film to have been punctured to cause this type of break, if the film surface has been marked in any way it can cause a weakness in the film that will cause it to break under tension in the PSU.

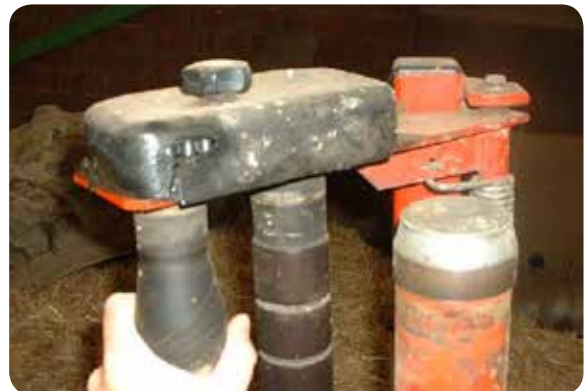
### PSU Gear Box

Worn or damaged gears in the PSU head can cause the gears to jam during the wrapping cycle. The bale will continue to turn, pulling the film through the PSU, however, the jammed gears will not allow the film to run, thus causing a tension break of the film.

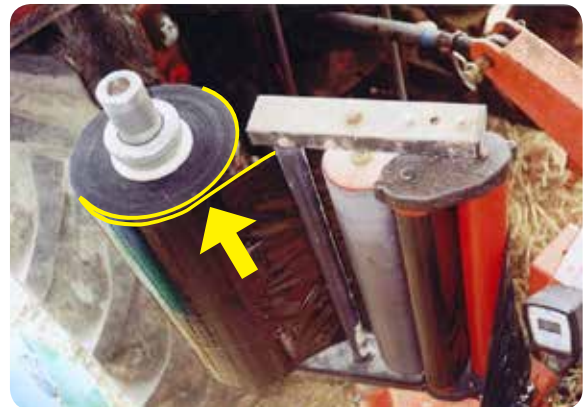
### Film Over-Run

If the film roll is allowed to over-run at the end of the wrapping cycle, particularly a full roll that will have a lot of turning momentum, it is possible the film will over-lap and stick to itself. If this happens, the film will come together on the sticky surface of the film, making it stick fast. As the wrapper begins the next wrapping cycle, the film will not run freely, as it is now stuck to itself. The bale will continue to pull against the film roll until, eventually, the film will snap, though over-tension.

This can also easily occur when travelling between bales when the film is not running, if the web of film between the film roll and the bale come together, particularly in windy conditions.

The film roll has over-run here, allowing the film to touch and stick together, as shown by the high-lighted edge of the film in the picture.
