## PROBLEM: FILM SPLITTING ON THE BALE

# STRETCHFILM TROUBLE-SHOOTING

Problem: Film splitting on bale

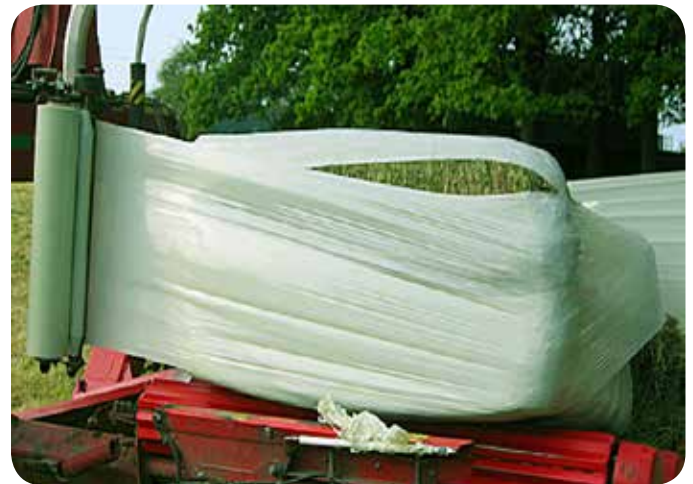
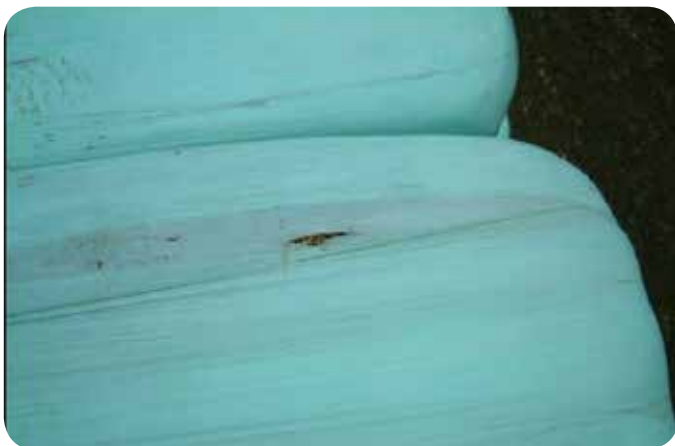
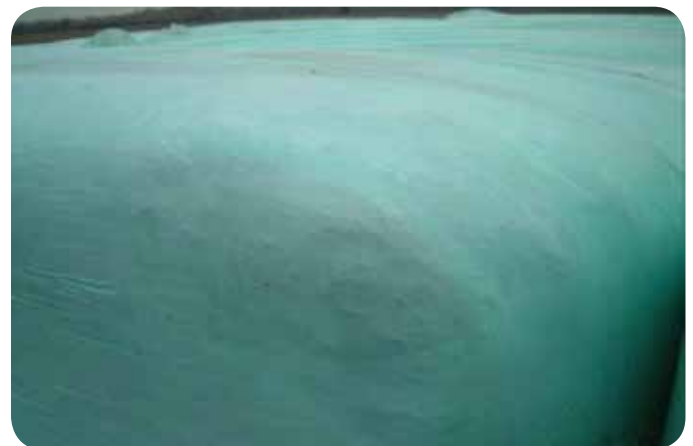
Deficiencies in wrapping square bales are very evident when using light coloured film. This is particularly critical on the corners.

All film manufacturers recommend that when wrapping square bales, irrespective of what type of crop you are wrapping, the bale should be wrapped as if applying 6 film layers.

Unlike a round bale, which maintains the same attitude on the wrapper as it rotates and provides a uniform shape for the film to be allied to, the attitude of a square bale is constantly changing as it turns on the wrapper. Because of this, the bale should be wrapped as if applying 6 film layers to the bale – this is the only way to **GUARANTEE AT LEAST 4 FILM LAYERS EVERYWHERE** on the bale.

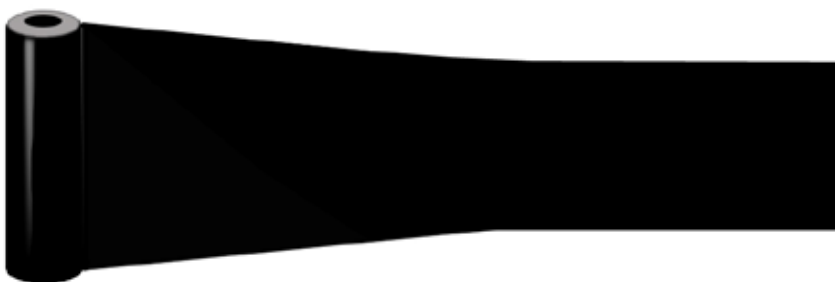
**70% STRETCH**

———— CORRECT FILM NECK-DOWN  
580mm – 600mm

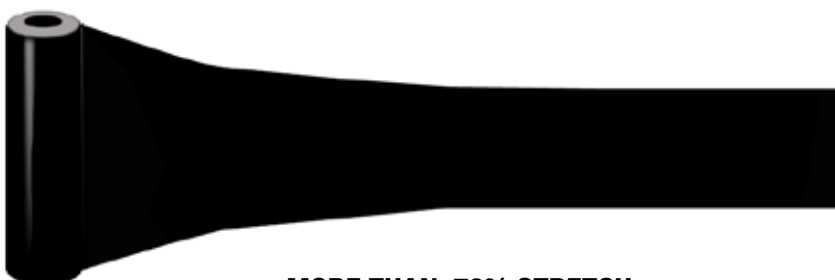
**MORE THAN 70% STRETCH**

If secondary stretch occurs, it will increase film 'neck-down' and reduce the amount of over-lap between each successive film layer, creating areas on the bale with less than the required number of layers.

———— IN-CORRECT FILM NECK-DOWN

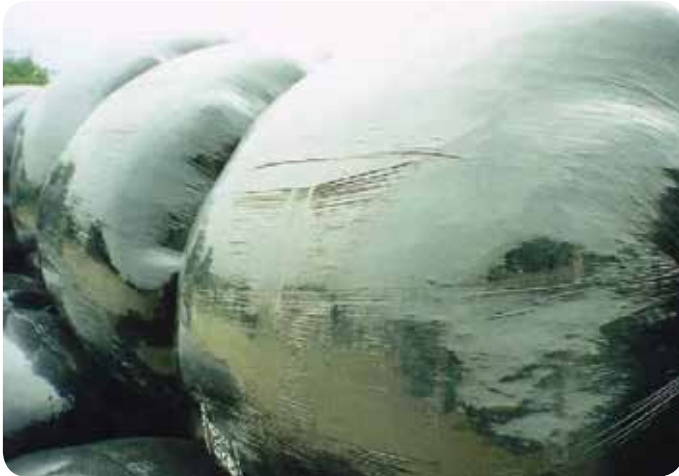
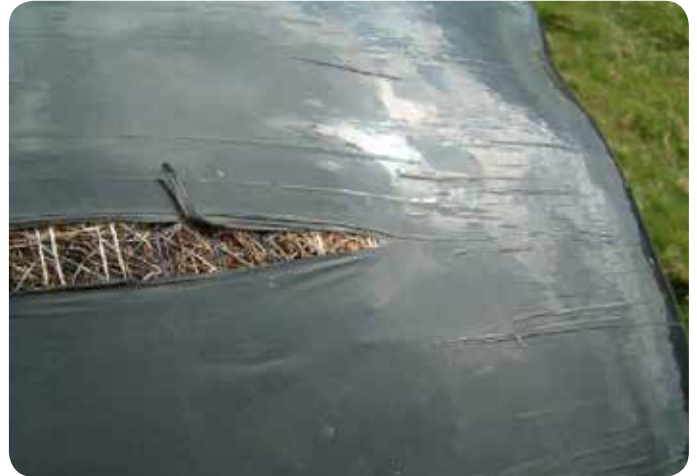
Areas of the bale with less than the minimum required (the elliptical shape on the bale side on the left above) are difficult to see on black bales. The part of the bale with fewer film layers will eventually split either through weathering or as the bale settles in the stack. By cutting the film from around the split, it is easy to see that the split occurred where there were fewer layers of film. Sometimes the wrapping is so in-correct that only a single layer covers the bale in some places.

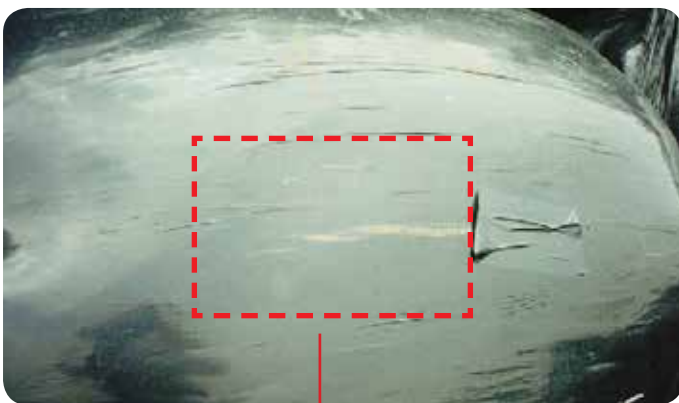
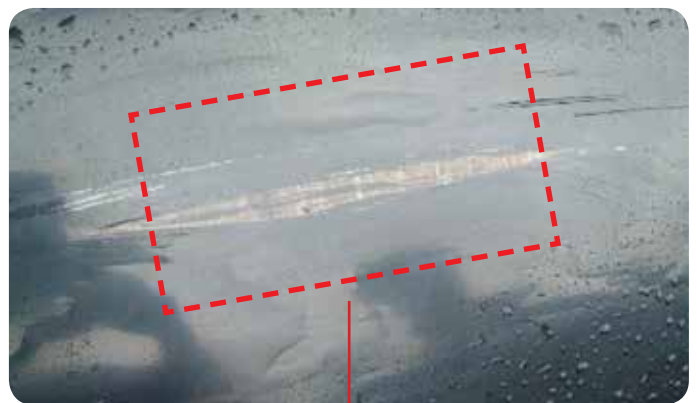
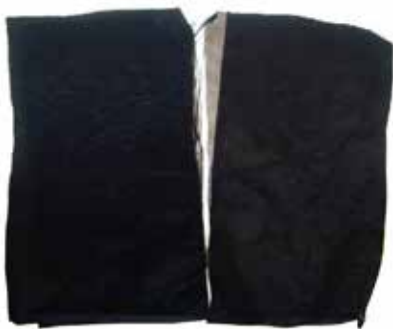
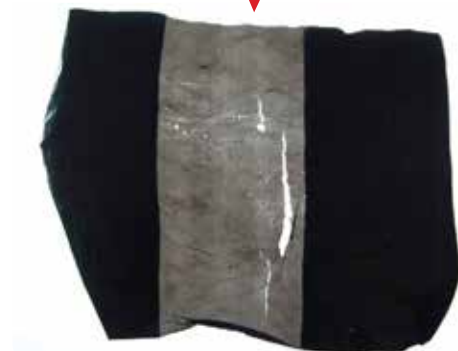
Samples were cut from the above bales and showed clearly that only one layer of film had been applied in these areas, instead of the recommended MINIMUM 4 layers.

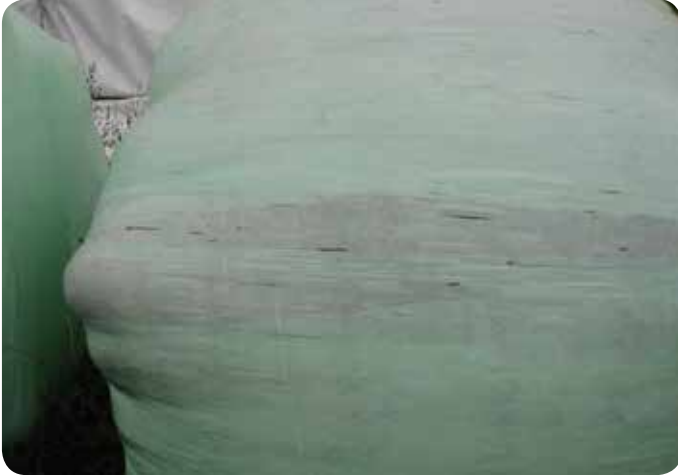
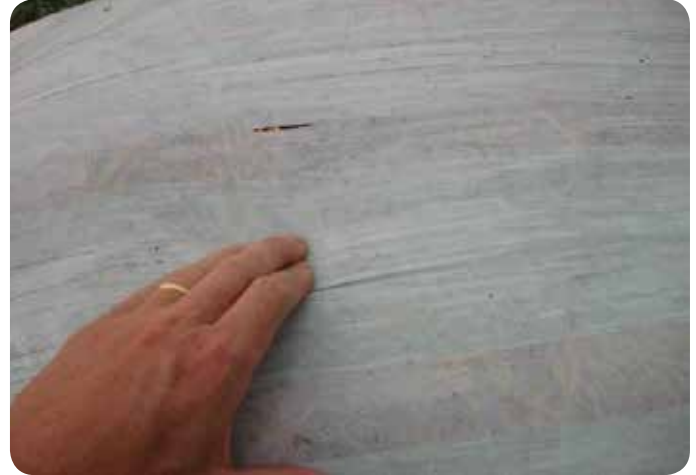
When wrapping bales using light coloured film, any parts of the bale covered in less film layers than required are easy to see, as the dark crop below shows up through the area with fewer layers.

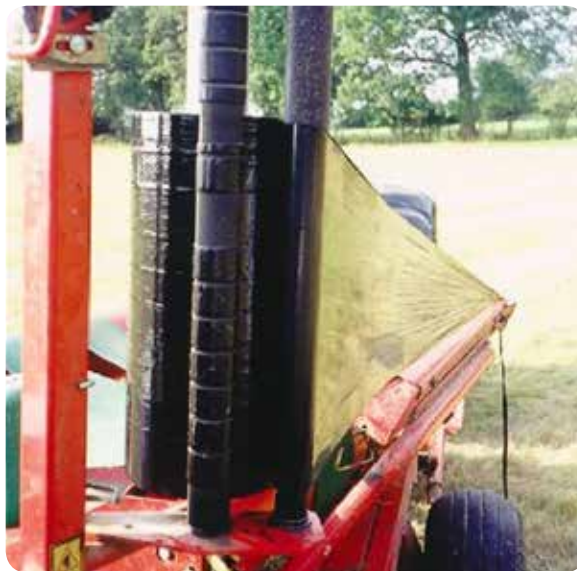
If the PSU rollers are sticky with film tack residue, the film will begin to stick to the rollers, causing 'secondary-stretch', which will reduce the film width being applied to the bale.

Note how the PSU rollers are shiny with film tack residue.

To over-come this, PSU rollers should be cleaned regularly, by rubbing vigorously with a cloth soaked in a solvent based cleaner. If the PSU has rubber coated rollers, it may be necessary to clean the surface then rub down with a hard wire brush, to create grip on the rollers.

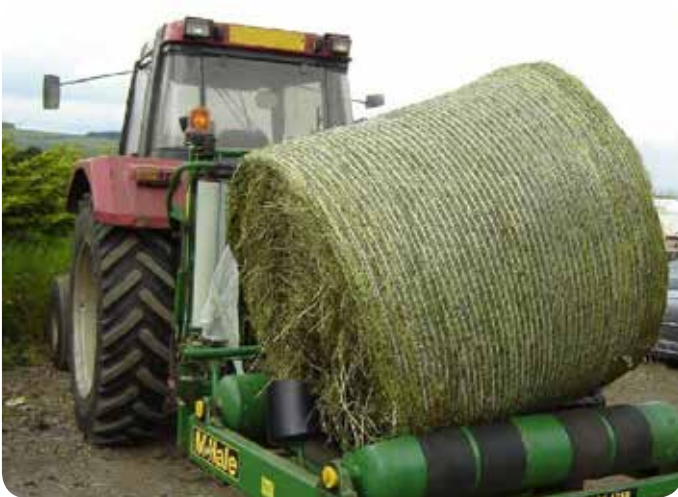
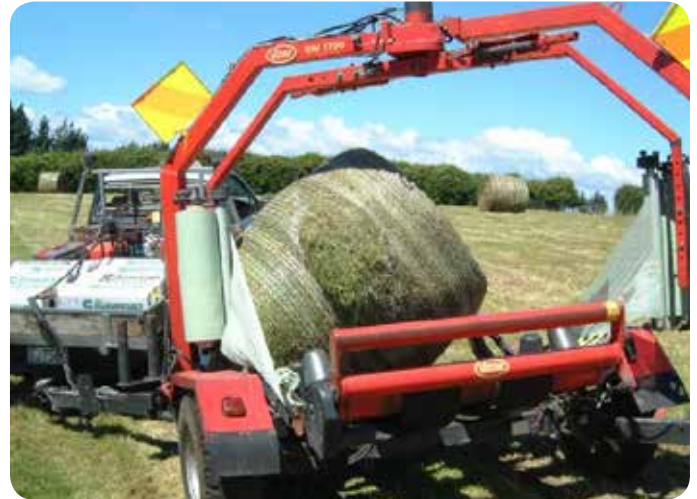
The bale should be correctly placed on the turntable, to allow it to index correctly and uniformly whilst rotating. If this practice is not followed, the film cannot be applied correctly to allow 50% over-lap due to the bale's in-consistent indexing and rotation. This is often worse when collecting bales for wrapping whilst on the move.

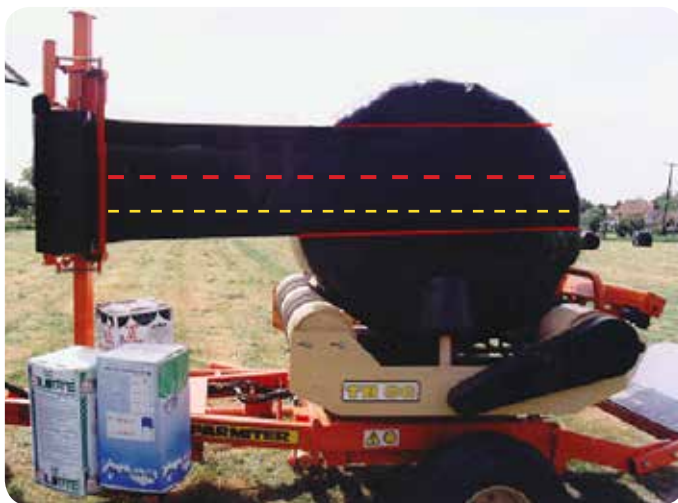
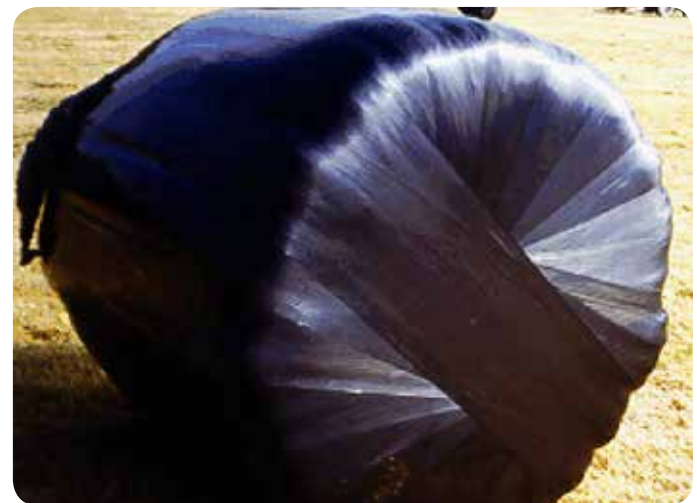
The bale on the left has in-correct film over-lap as the film roll is positioned too high for the bale (film roll centre-line marked in red - bale centreline marked in yellow), meaning the centre of the film is not in line with the bale's centre of rotation.

The bale on the right shows the correct pattern of film overlap, with the film roll correctly aligned against the bale.

The film roll should be aligned correctly with the bale, neither too low nor too high. If this is not checked, the application of film will be affected as the bale turns, making the film not in line with the 'centre of rotation' of the bale.
