## PROBLEM: FILM SPLITTING ON THE BALE

# STRETCHFILM TROUBLE-SHOOTING

Problem: Film splitting on bale

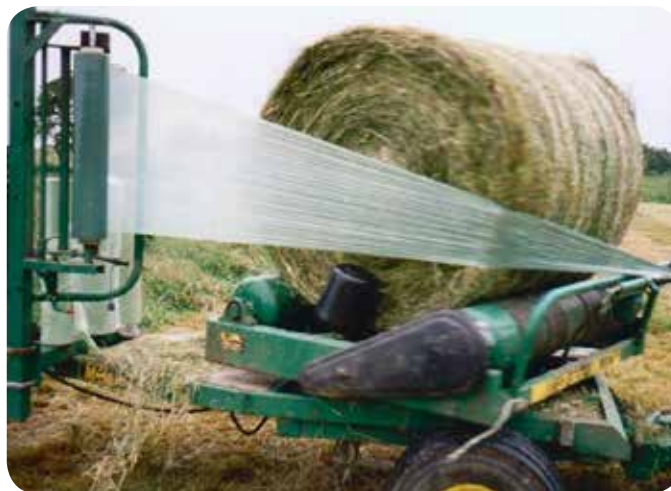
If the bale diameter is slightly more than 1.2m, the diameter becomes greater, which affects the accuracy of the planned 50% over-lap. In this instance, more turns will be required to ensure full and complete coverage of the bale.

Remember, it takes half a turn (two sides of the bale) for the film to open up to its full width on the bale.

1. Count the number of turns required to completely cover the bale
2. Add one extra turn (to compensate for the narrowing of the film from the start of the cycle, when the film is held in the cut and catch mechanism)
3. Multiply this number by 2 for 4 film layers or by 3 for 6 film layers

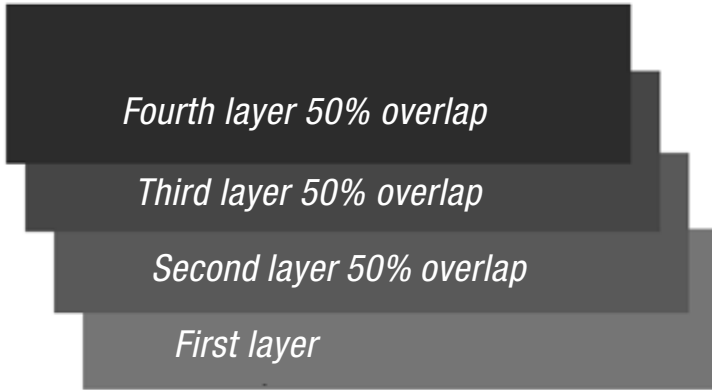
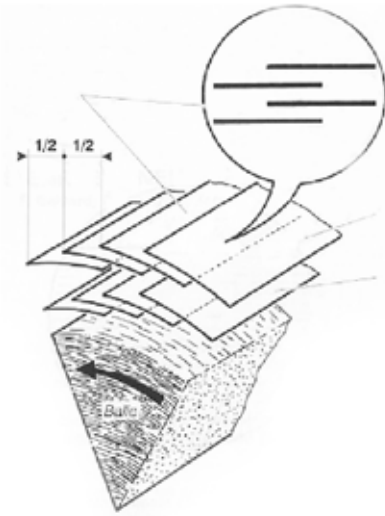
**MINIMUM 4 layers 50% overlap (2+2)**

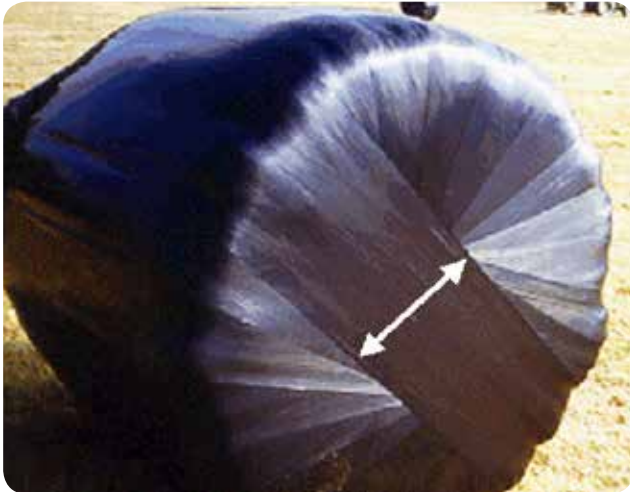
The Pre-Stretch Unit (PSU) on the bale wrapper is calibrated, through the gears, to stretch the film between the paired rollers by 70%; this is to ensure the film width over-laps by the required 50% over-lap. However, there is the possibility that the film will also stretch between the rollers and the bale, when the film will 'neck-down' more than it should, which will affect the % over-lap of each film layer application to the bale.

This can easily be checked by measuring the width of the last film application on the end of the bale.
